Recommendations for the Weatherization of
The SAMPLE Residence
STREET – CITY, STATE ZIP

Observations and Recommendations

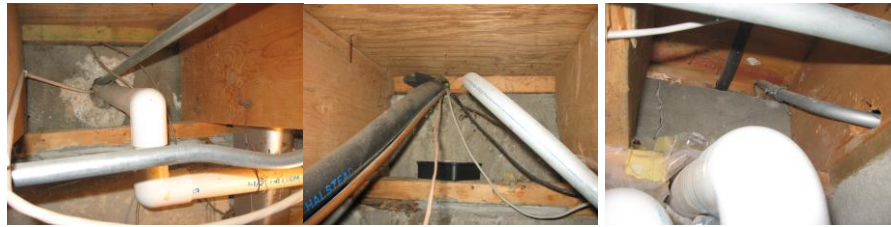
- Exposed rim joist, perimeter of space under laundry room and south wall of furnace room

- o Remove fiberglass batt insulation from box sill spaces and set aside, air seal penetrations and insulate box sill spaces with spray foam insulation, replace fiberglass batts.
- Open bypasses where walls meet ceiling of furnace room

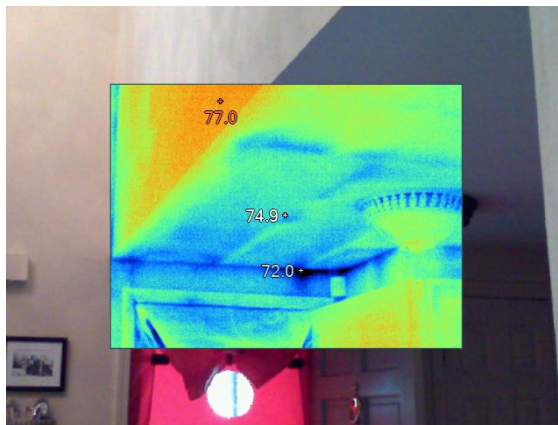
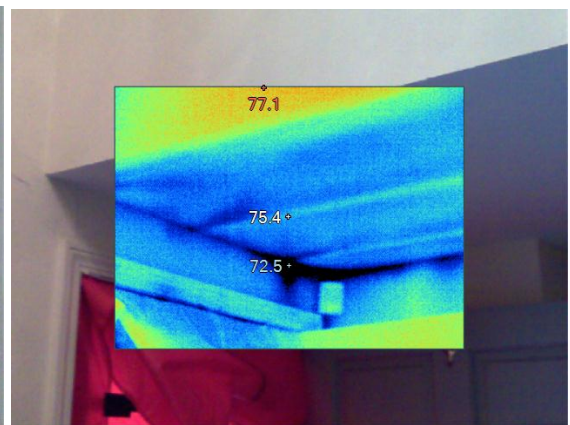
- Ceiling at entry shows air infiltration under blower door testing. Cut access through ceiling and dense pack area (30 ft³) above entry with cellulose insulation, close ceiling and prep for paint.

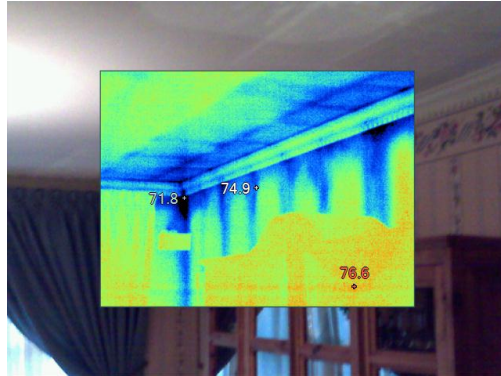
- Dining Room

- Air infiltration in dining room ceiling/floor of bedroom above. Ceiling (along west wall), air infiltration under blower door test indicates need for air sealing. Recommend gaining access to joist cavity by cutting ceiling, dense packing ceiling joist space with cellulose insulation, closing ceiling and prepping for paint.

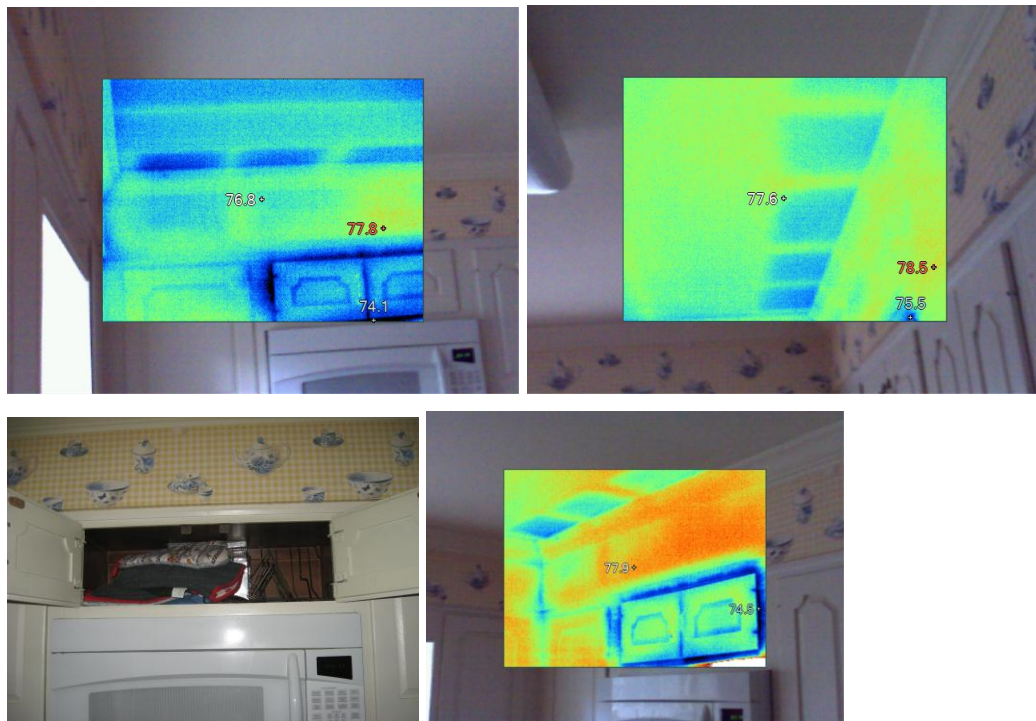
- Kitchen

- Soffit above stove and stove hood duct need air sealing. Suggest opening ceiling adjacent to soffit, dense pack joist spaces with cellulose, close ceiling and prep for paint.

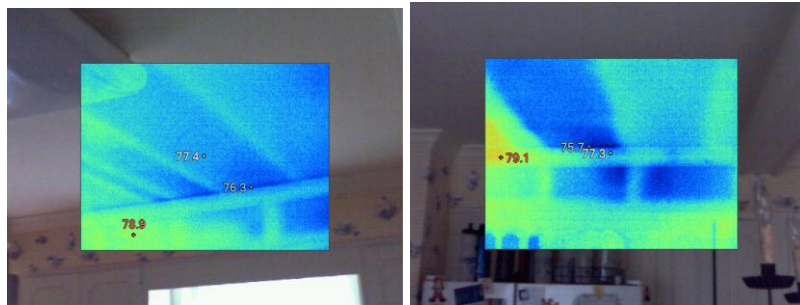
- Two to three joist spaces above kitchen showed air infiltration under blower door testing. Suggest gaining access, dense packing with cellulose insulation, closing ceiling and prepping for paint.

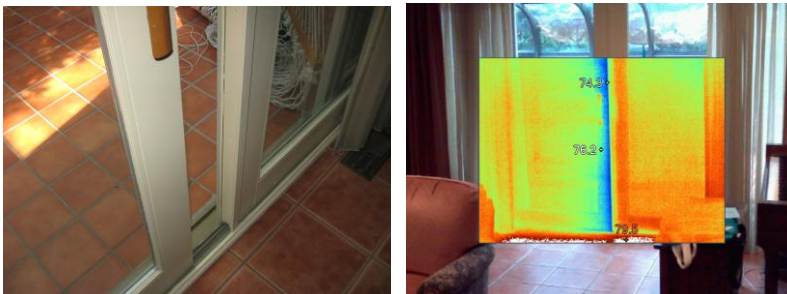
- Sitting room

- Sliding door lacks weather strip and leaks lots of air during blower door test.
 - Add weather strip to vertical mating edge of sliding doors

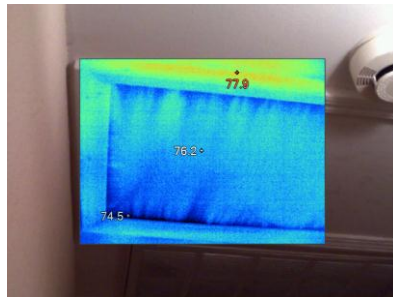
- Attic access hatch leaking air under blower door test conditions

- Air seal perimeter with weather strip and insulate panel with rigid foam.
- Air seal trim with caulk

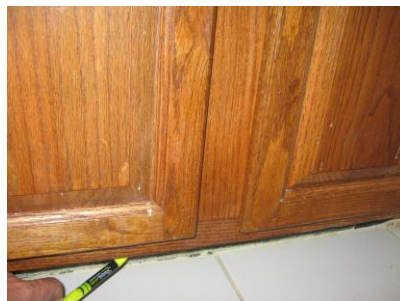
- Hall bath

13	Bath His	+13.5	Gap under vanity cabinet leaking lots of air during blower door testing.

- Block and air seal base of vanity cabinet with fiberglass batt insulation
- Air seal plumbing penetrations beneath sink

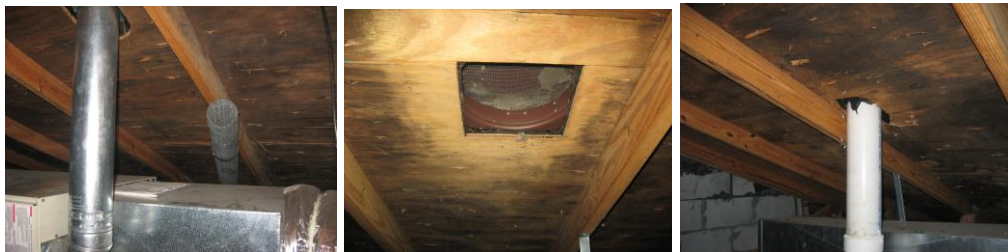
- Signs of poor ventilation include mold on underside of roof deck due to excess moisture. Recommendation is to contact a mold remediation company. Our recommendation is to contact Evan Kane at RGC, 312-953-5205 to schedule an inspection.
Our sales manager Tom Decker knows Evan and is confident he can help.

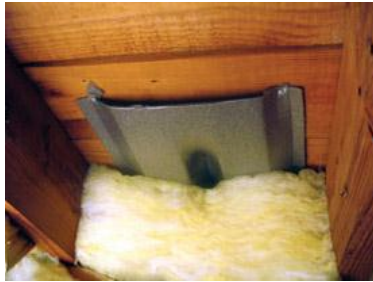
- Existing roof and soffit vents are inadequate. Insulation should be moved from soffits, baffles should be added to rafters to direct vent air to roof deck. Number of soffit vents should increase to meet ventilation requirements.
- Insulation
- Six (6) to eight (8) inches of blown-in fiberglass is below the R-38 level recommended by the U.S. Department of Energy for our climate. Recommend additional six (6) inches of blown fiberglass over existing insulation.

Place rafter vent baffles in between the rafters (DOE photo)
